## Bat Safe Roofing and Cladding Membranes

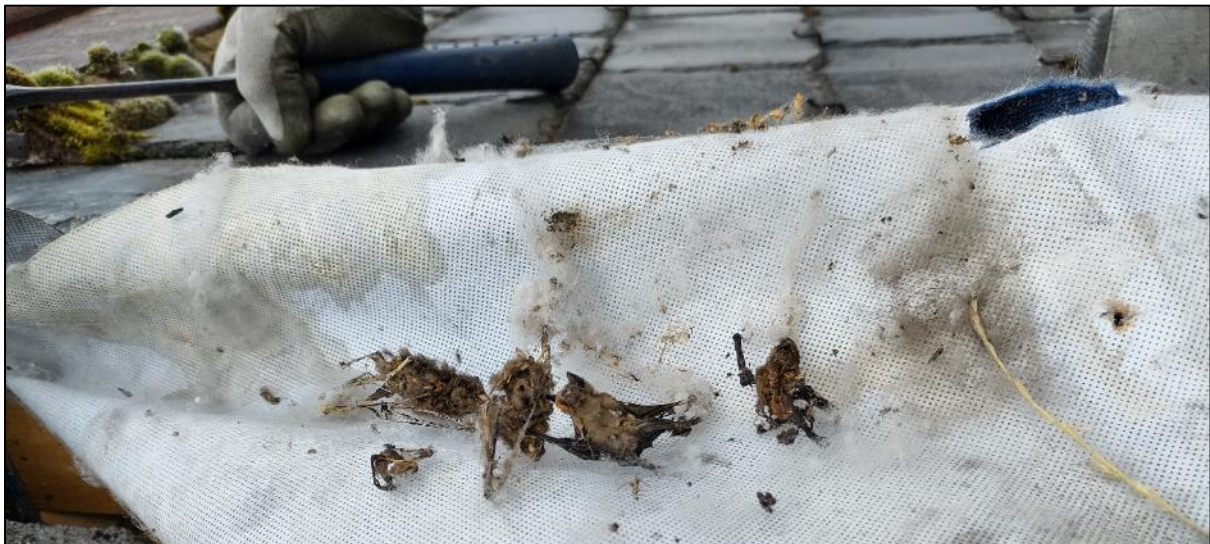
Standard non-bitumen coated membranes (including almost all breathable membranes) used below roof slates and tiles present a significant problem for bats. Over time, strands are pulled away from the surface of these materials as bats crawl over them. These fuzzy strands are very strong and can tangle and trap bats, sometimes causing the death of bats over multiple years<sup>1</sup>.

One example we have encountered comprised a pipistrelle roost which formed in a building extension constructed in 2009. Over the course of just 13 years the roofing felt degraded to the extent that it trapped and killed more than 10 bats. Fortunately, the problem in this roost was identified and remedial work was undertaken to replace the roofing membrane in 2022.

### Plate 1. Four dead pipistrelles tangled in breathable roofing membrane

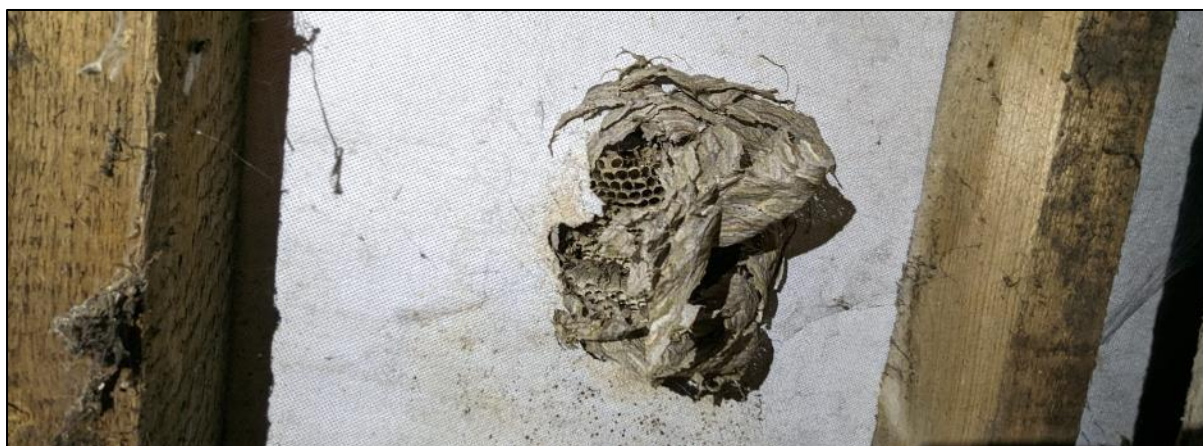
In recent years a fairly substantial proportion of the lofts we have surveyed which had existing breathable felt, were found to have been damaged by wasps (Plate 2). The wasps appear to have chewed holes in the felt and formed nests. This doesn't appear to be a problem associated with traditional bitumen coated roofing felt. Any holes within roofing felt are likely to significantly reduce its functionality as a secondary weather barrier. Where bats or birds come into contact with breathable roofing membranes, they can also damage it causing it to leak, they can also significantly reduce the breathability of the felt in that location.

#### **Plate 2. Damage to a breathable roofing membrane adjacent to a wasp nest**
